WARRINGTON TOWNSHIP RETENTION BASIN

PHASE I INSPECTION REPORT
NATIONAL DAM INSPECTION PROGRAM

NDS I.D. NO. PA 01066,
DER I.D. NO. 9-176

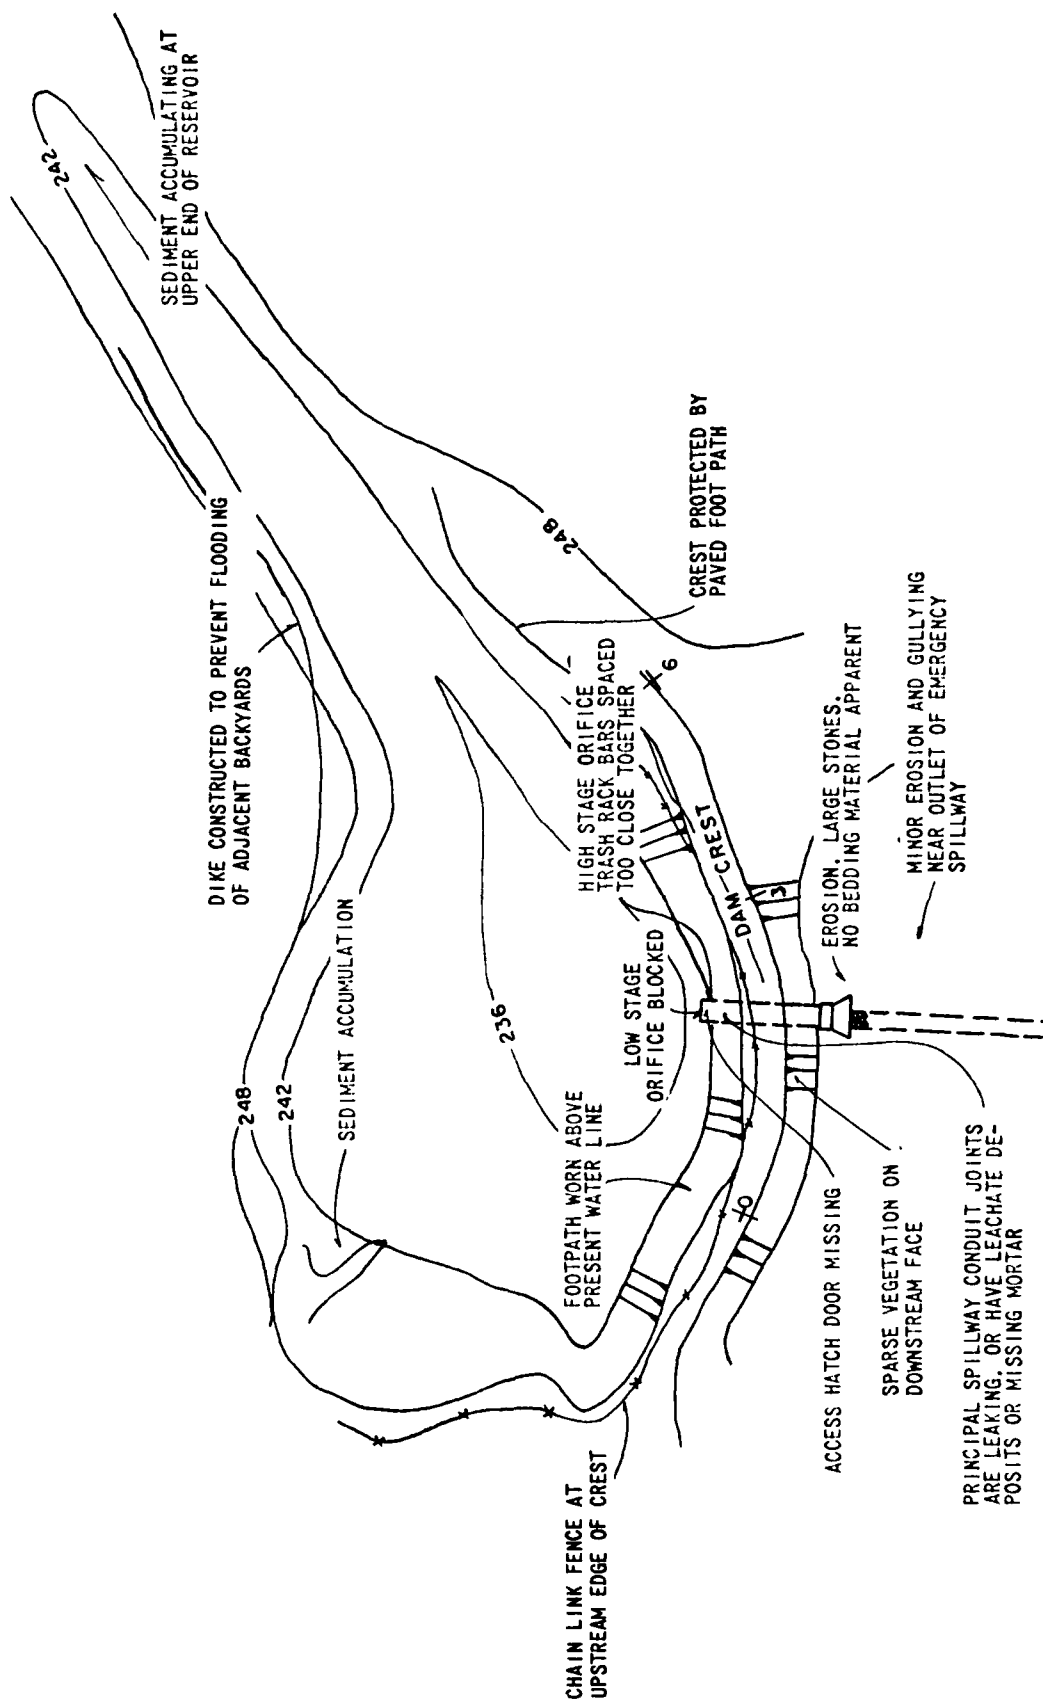
FIELD OBSERVATION PLAN
WARRINGTON TOWNSHIP RETENTION BASIN

VISUAL EXAMINATION OF	OBSERVATIONS	REMARKS OR RECOMMENDATIONS
VEGETATION	Conditions of vegetation ranges from good to poor. On downstream face grass is sparse. Crowsfoot and grass on upper portion of upstream face is in good condition. Grass near water line is in fair condition.	
JUNCTION OF EMBANKMENT AND ABUTMENT, SPILLWAY AND DAM	Upstream and downstream junctions of abutment and embankment in good condition. Erosion has occurred at the downstream end of the outlet structure. Large stone with no bedding material is placed where erosion has occurred, See Photograph 11.	
ANY NOTICEABLE SEEPAGE	None observed.	
STAFF GAGE AND RECORDER	None	
DRAINS	None
